TANK 4 AND LEACHATE TRANSMISSION SYSTEM REPORT

CONSTRUCTION QUALITY ASSURANCE (CQA)

ERDF CONSTRUCTION CELLS 9-10

## CQA PHOTOGRAPH LOG WEEK 35 (10/4/10 TO 10/9/10)

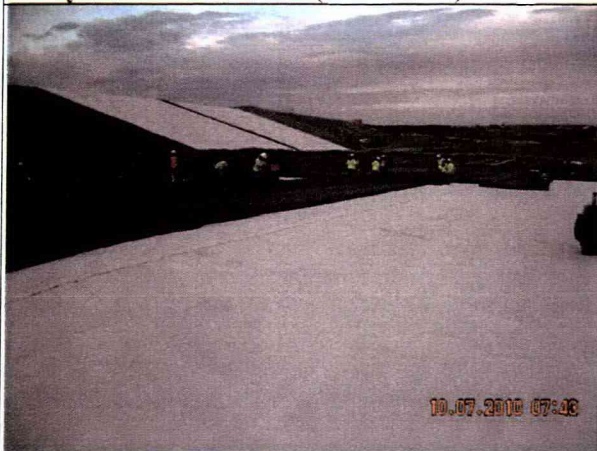
Facing NW – ESI deploying secondary geocomposite on the north side of the Cell 10 floor.

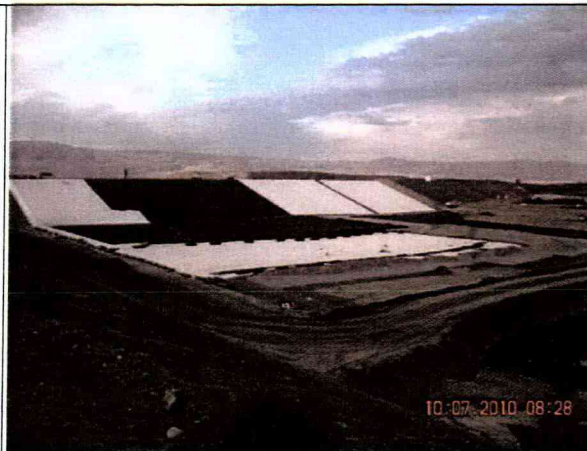
Facing NW – Deployment of geocomposite in Cell 10.

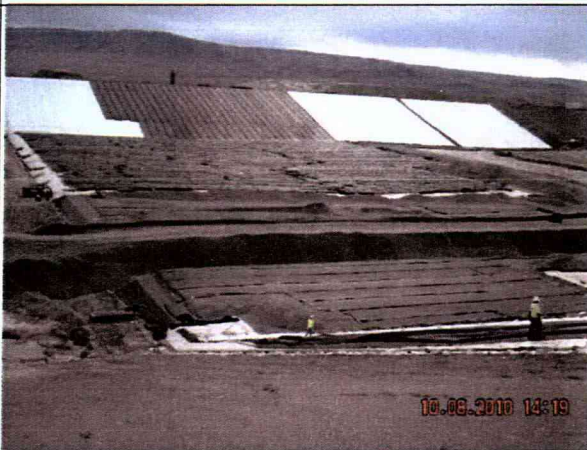
Facing S – ESI completing deployment of secondary geocomposite on the floor of Cell 10.

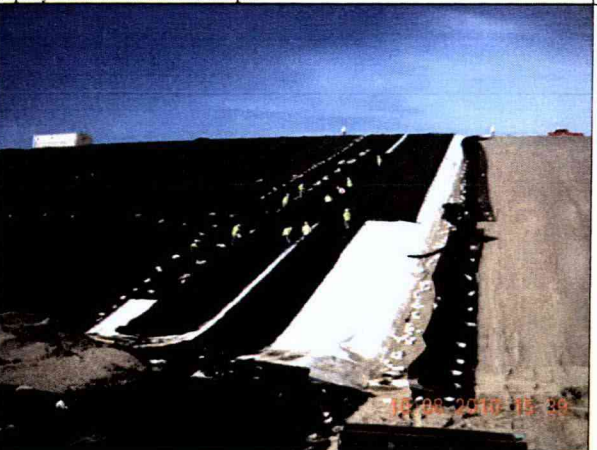
Facing N – ESI finishing the primary geocomposite near the rain flap on the north embankment of Cell 10.

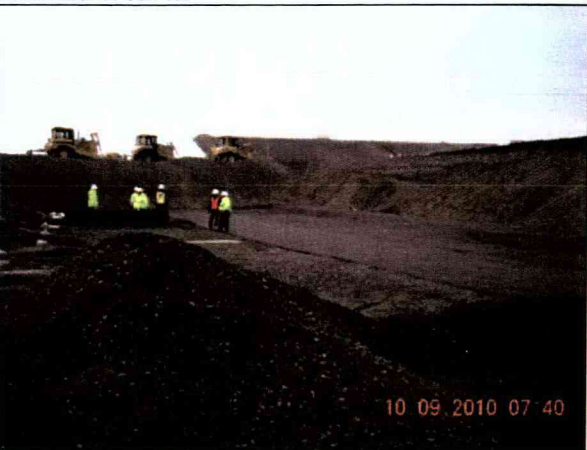
Facing S – ESI is placing 8-oz. geotextile over the primary drain rock directly south of the Cell 9 sump.

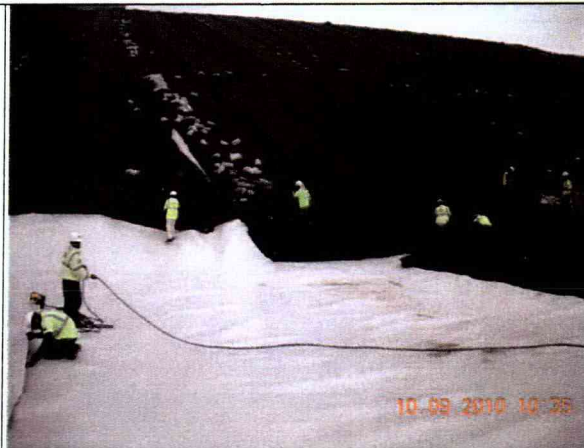
Facing N – ESI placing primary composite on the north slope of the Cell 10 near the sump. Also, ESI is welding the 100-mil rub sheet together in the Cell 10 sump.

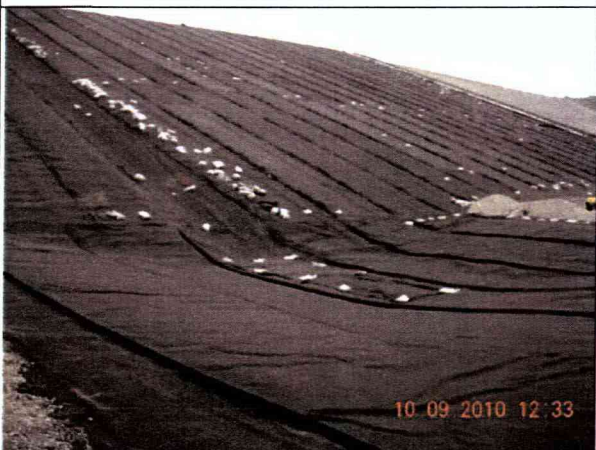
Facing NE – the Cell 10 sump is complete with the 100-mil rub sheet and 16-oz fabric in place.

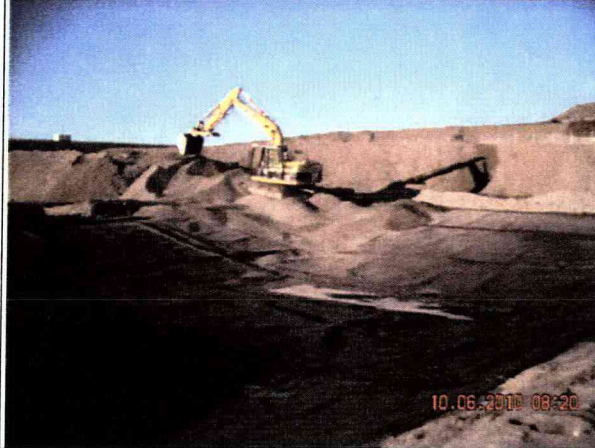
Facing W – TWS is beginning the placement of the Type C drainage gravel in the Cell 9 sump.

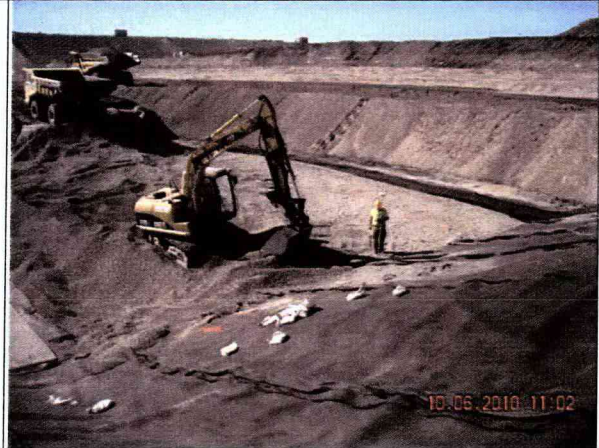
Facing SW – TWS placing Type C drainage gravel in the cell 9 sump.

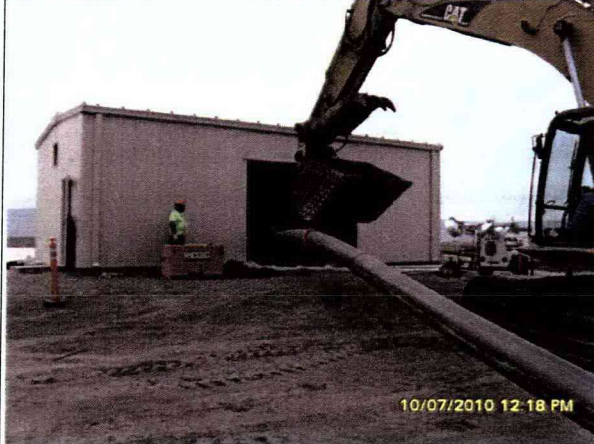
Facing S – TWS placing the primary 12-in riser pipe through the Cell 9 crest pad building and riser trench.

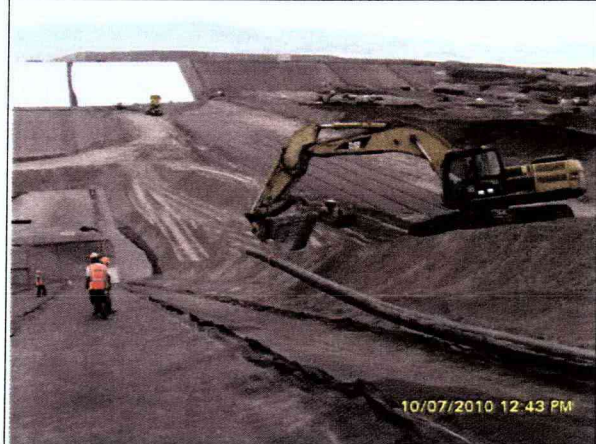
Facing S – TWS walking the primary 12-in riser pipe down the Cell 9 riser.

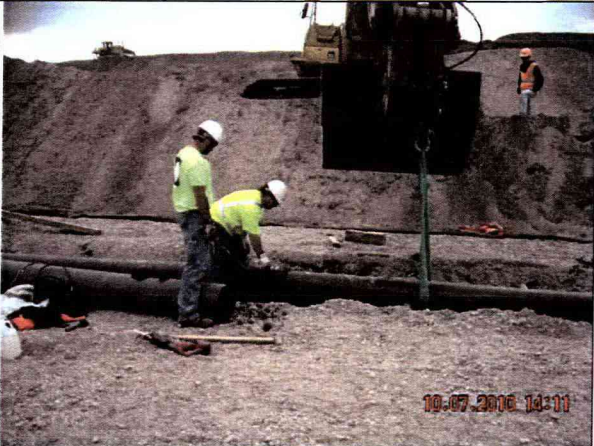
Facing W – BMWC utilizing a fusion coupler to join the leachate collection pipe to the riser pipe in Cell 9.

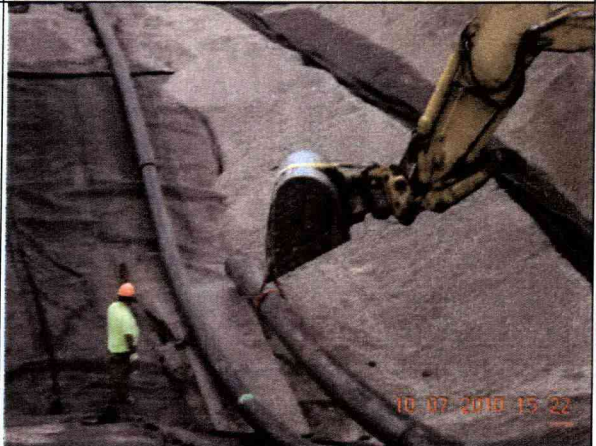
Facing S – TWS placing the primary 18-in riser pipe onto the HDPE flat stock in the Cell 9 sump.

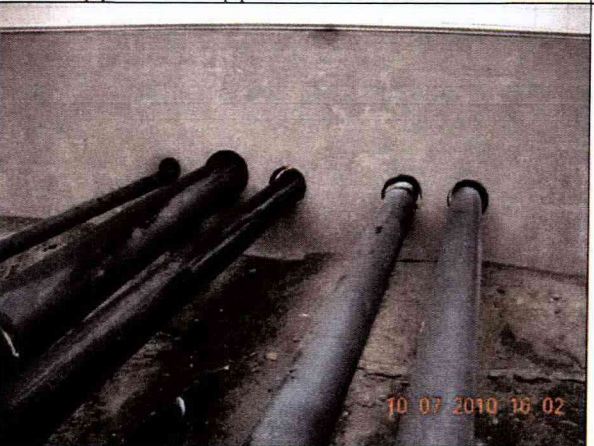
Facing N – All the primary and secondary riser pipes penetrating through the Cell 9 crest pad stem wall.

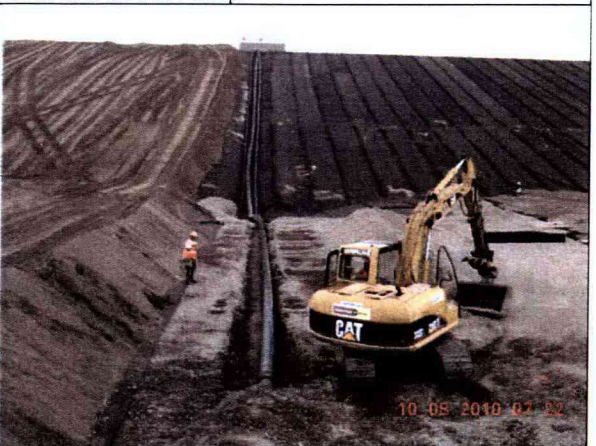
Facing N – TWS placing drainage gravel over the leachate collection pipe in Cell 9.

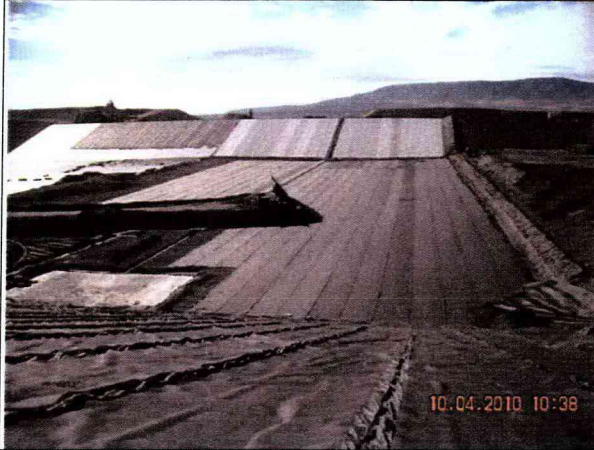
Facing S – TWS placing the north operations haul road into Cell 9.

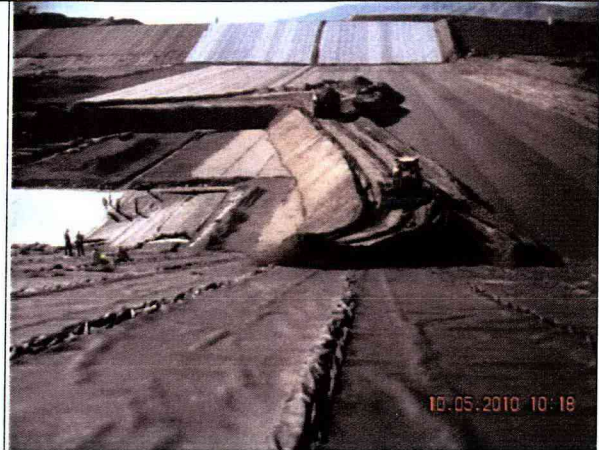
Facing S – TWS turning the north operations haul road north to the toe of the north slope of Cell 9.

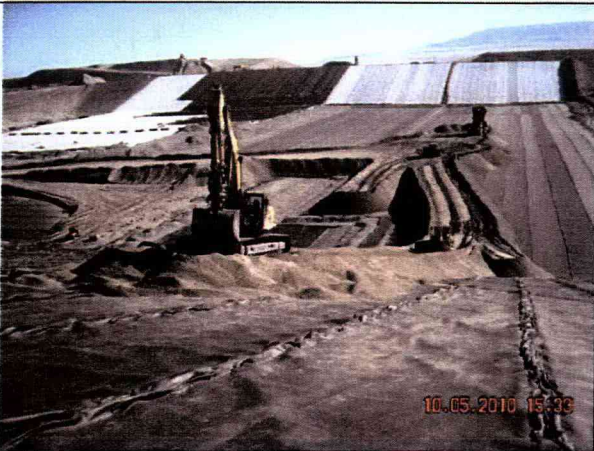
Facing S – TWS placing operations up the north slope of Cell 9.

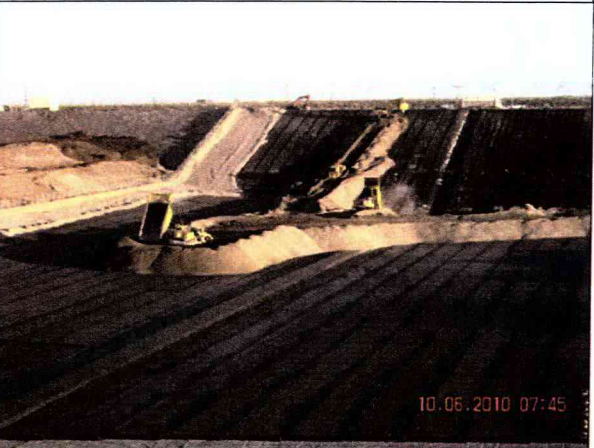
Facing S – TWS turning the north operations road toward the south berm in Cell 9, while a dozer spreads soil up the north berm.

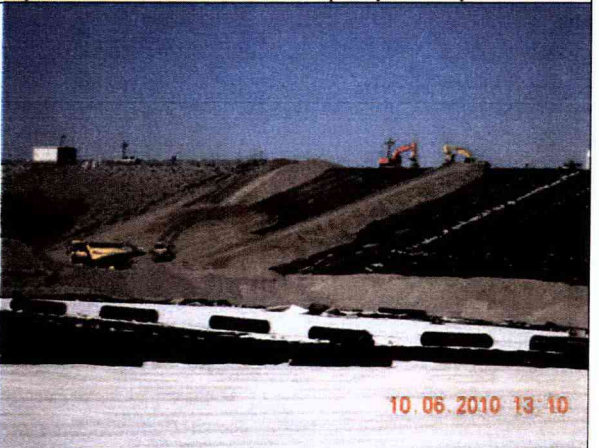
Facing NW – TWS placing operations fill on the north berm of Cell 9, while two (2) excavators backfill the north anchor trench.

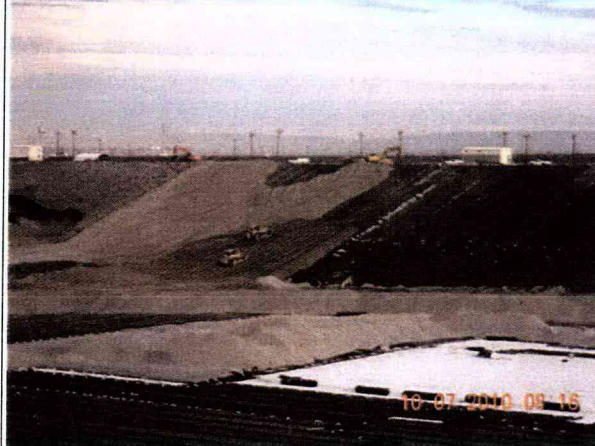
Facing NW – TWS placing operations fill on the north berm of Cell 9.

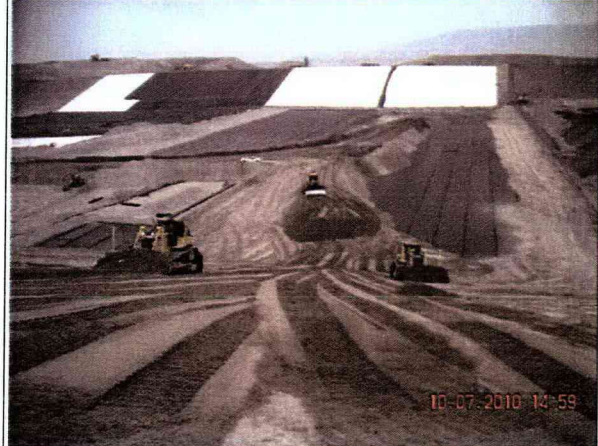
Facing S – TWS placing operations fill on the north berm of Cell 9.

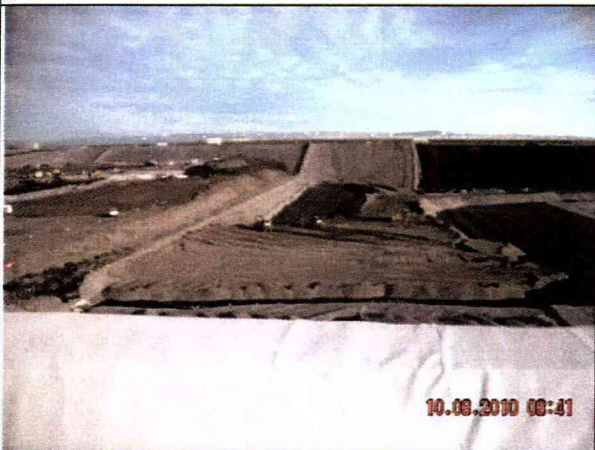
Facing S – TWS spreading operations soil in a 3-ft high lift across the floor of Cell 9.

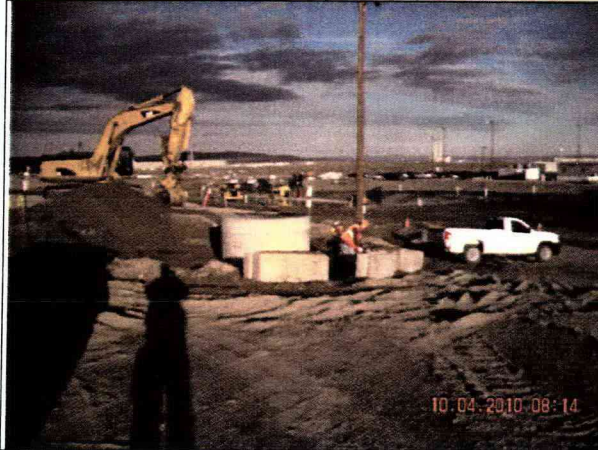
Facing NW – TWS installing a riser ring on MH-35.

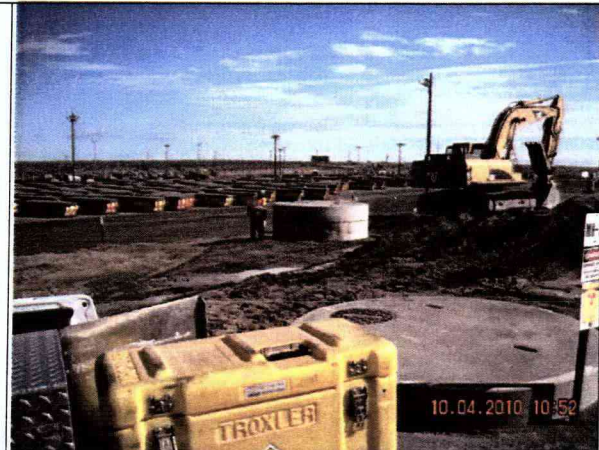
Facing NE – TWS backfilling around MH-35.

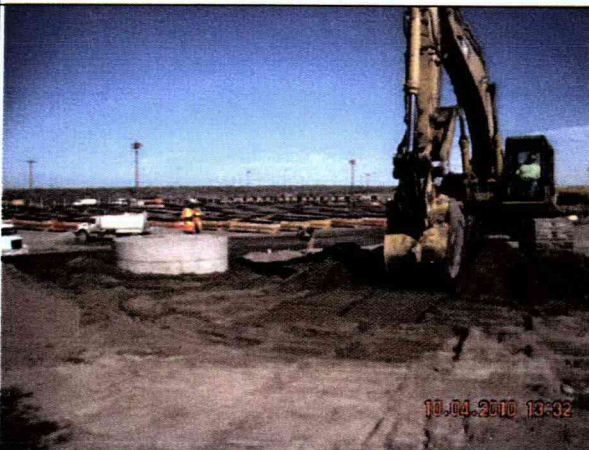
Facing NE – TWS backfilling and grading around MH-35.

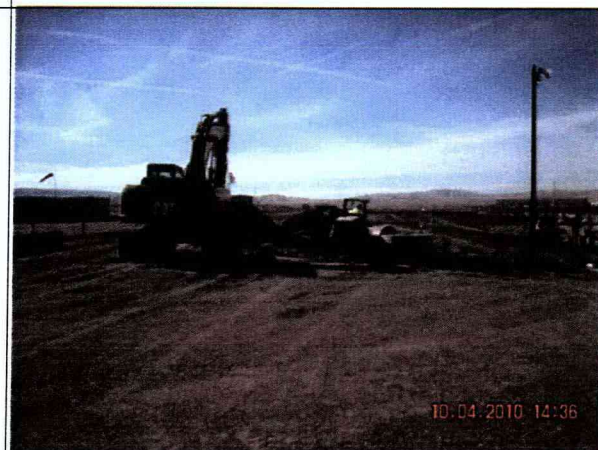
Facing W – TWS compacting backfill around MH-35.

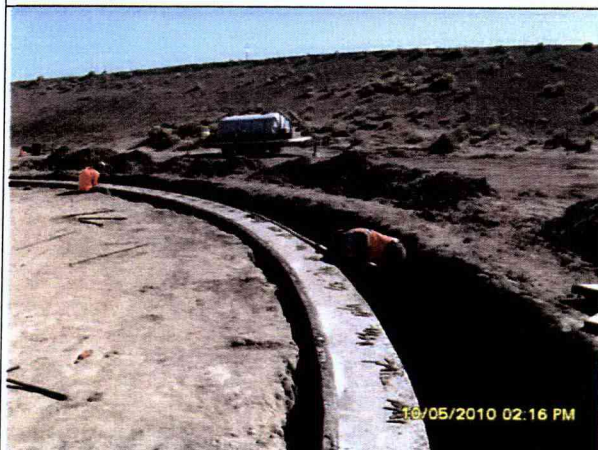
Facing S – TWS stripping concrete forms from around the Tank #4 ringwall.

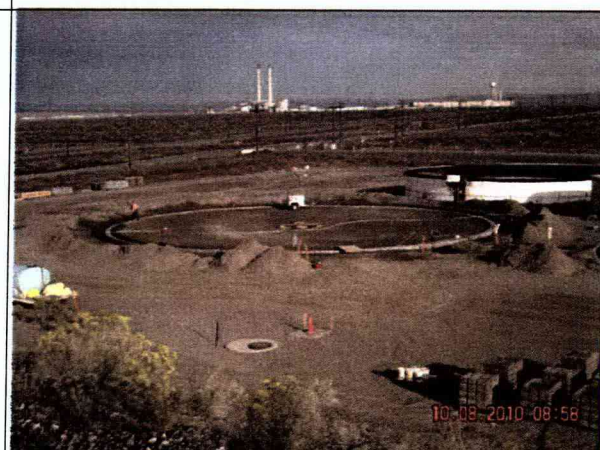
Facing NW – TWS stripping concrete forms from around the Tank #4 ringwall.

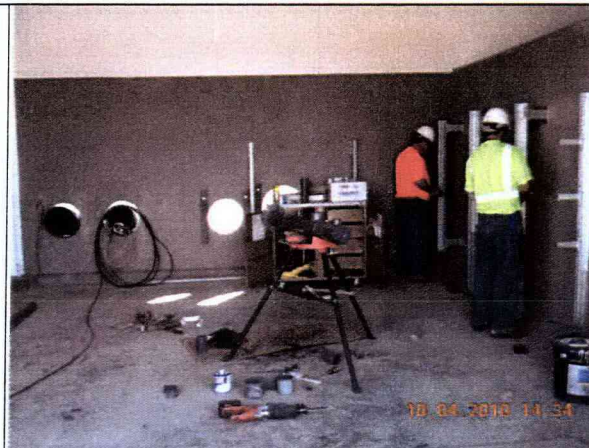
Facing NE – TWS backfilling around MH-35.

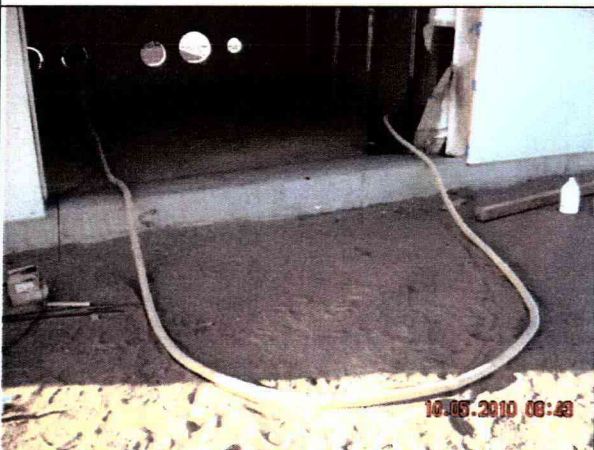
Facing NE – TWS backfilling and grading around MH-35.

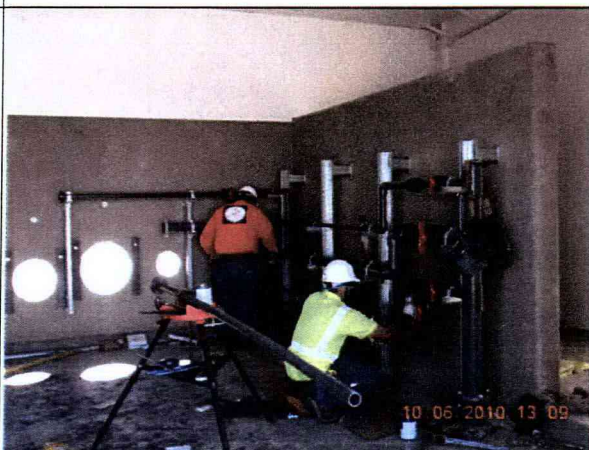
Facing W – TWS compacting backfill around MH-35.

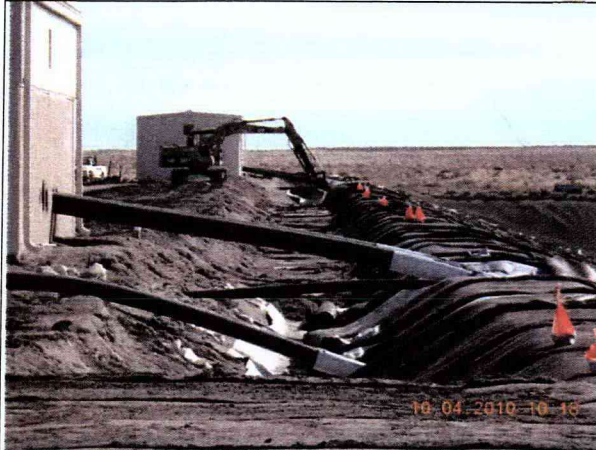
Facing E – TWS placing fill in the north anchor trench of Cell 10.

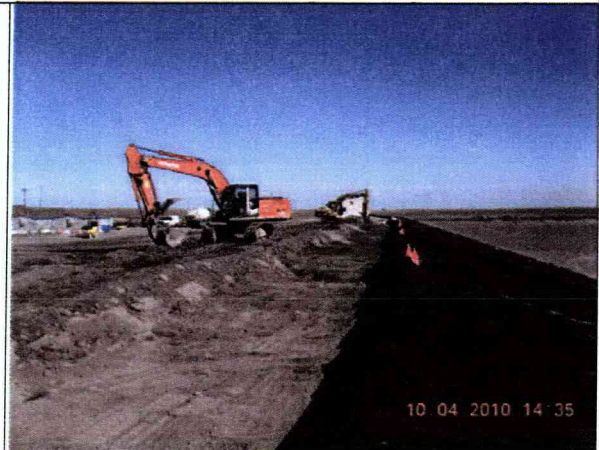
Facing E – TWS backfilling the Cell 9 anchor trench with an excavator, while a second excavator compacts the fill in Cell 10.

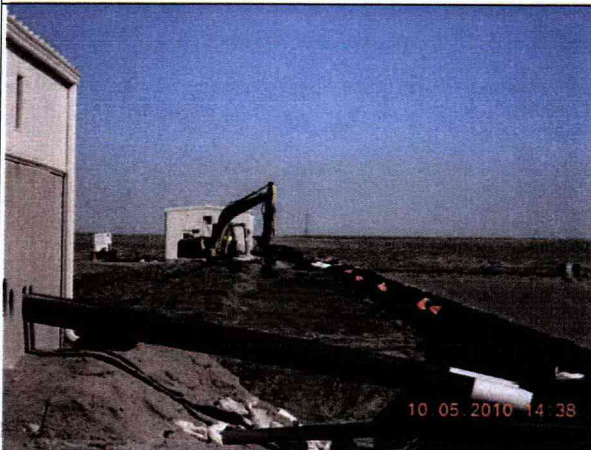
Facing NE – TWS compacting the backfilling the Cell 9 anchor trench.

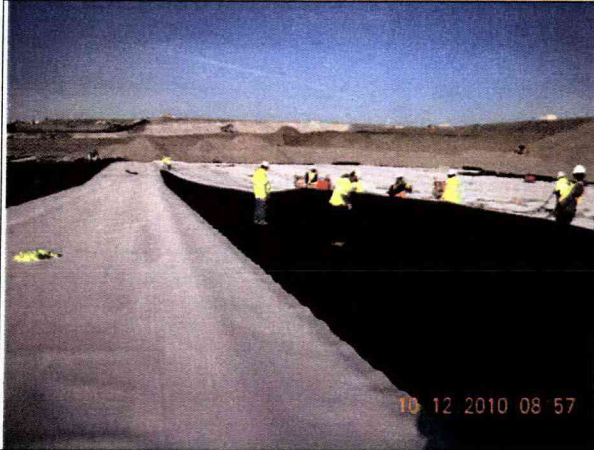
Facing W - ESI installing primary liner on the floor of Cell 10.

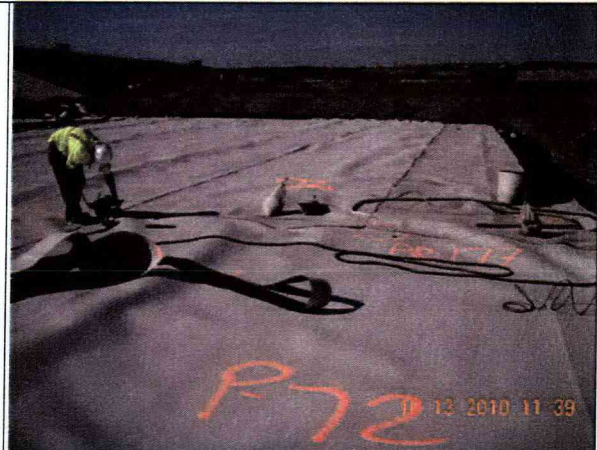
Facing W - ESI double wedge welding primary liner on the floor of Cell 10.

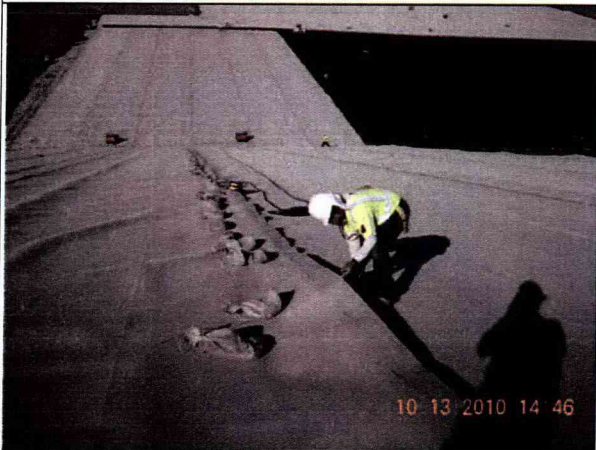
Facing N - ESI double wedge welding primary liner on the south slope of Cell 10.

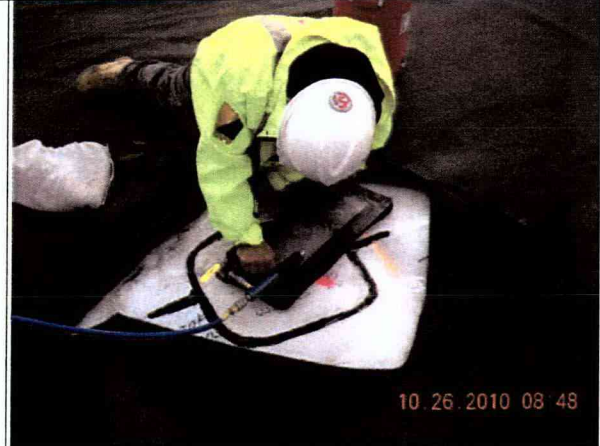
Facing S – ESI performing vacuum box tests on all extrusion welds.

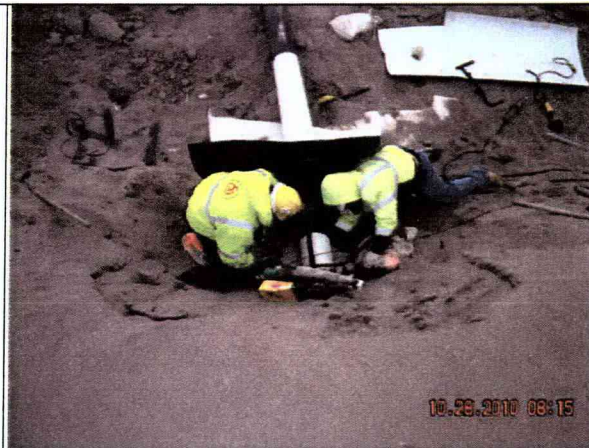
Facing N – ESI rewelding the pipe skirt for the Cell 9 lysimeter pipe.

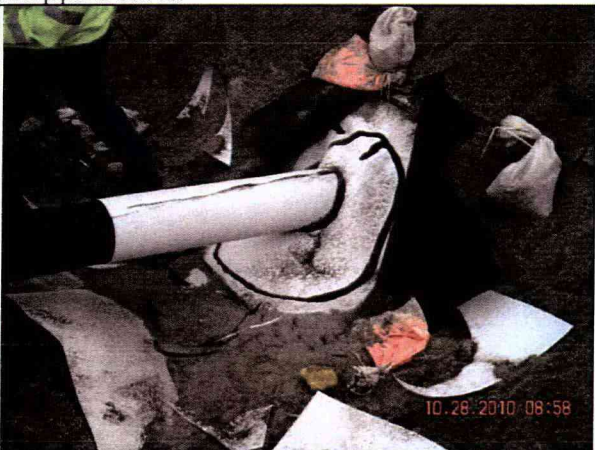
Facing Down – Due to the configuration of the pipe, a new boot was welded on the Cell 9 lysimeter pipe.

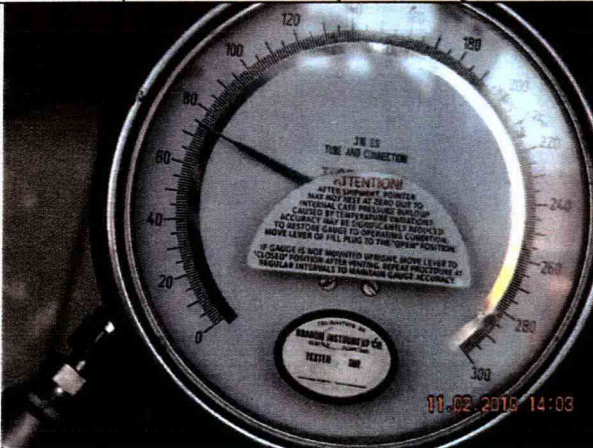
Crest Pad 10 – Beginning pressure of approx. 75-psi.

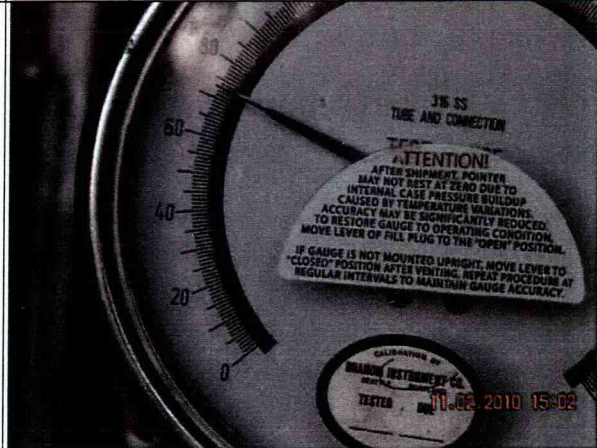
Crest Pad 10 – Ending pressure of approx. 73-psi.

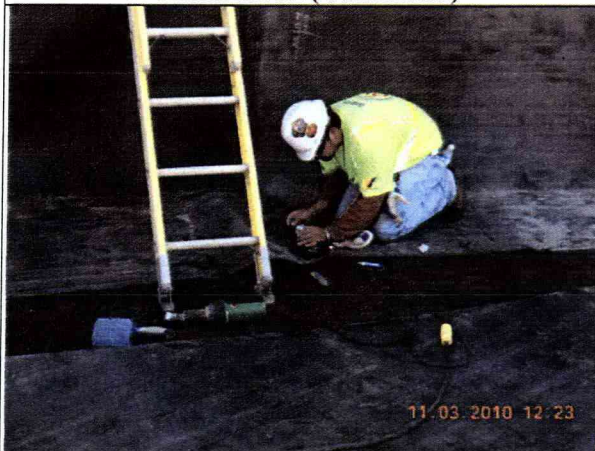
Tank 3 – ESI pressure testing the secondary seams inside of Tank 3.

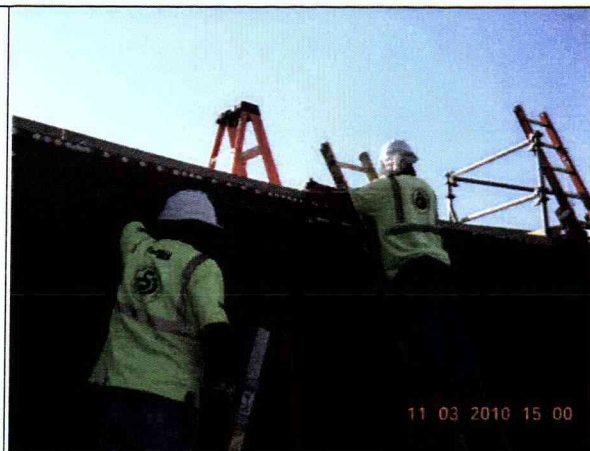
Tank 3 – ESI installing the baton strip at the top of Tank 3. Only 1/3 were installed at this time.

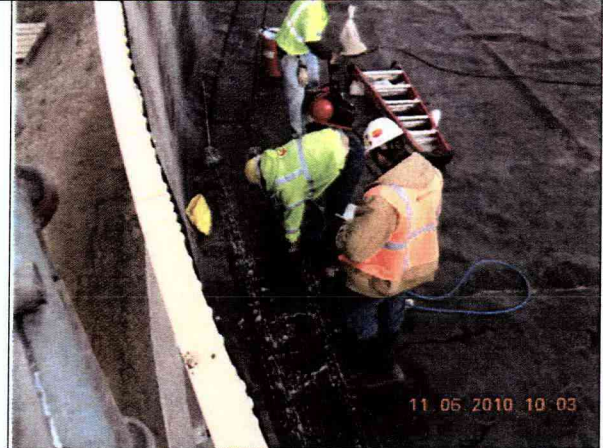
Tank 3 – ESI vacuum testing all extrusion welds in Tank 3 with CQA oversight.

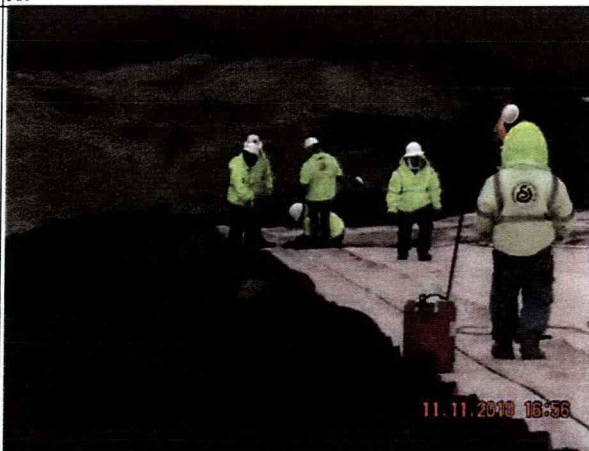
Facing N – ESI preparing to vacuum test the rain flap extrusion welds on the south slope of Cell 10.

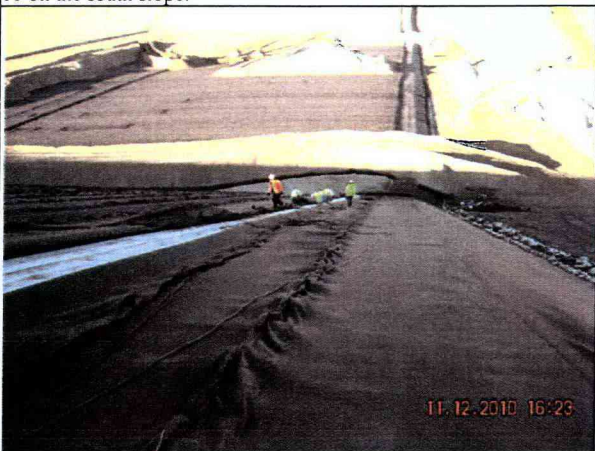
Facing N - ESI vacuum testing the rain flap on the south slope of Cell 10.

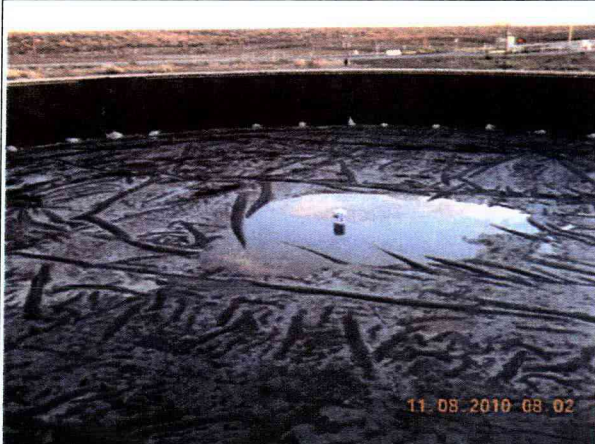
Tank 3- Overnight rains have left standing water in Tank 3.

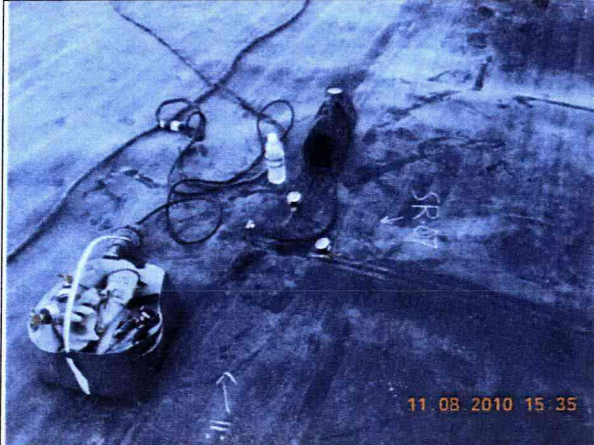
Tank 4- ESI is pressure testing the secondary seams in Tank 4.

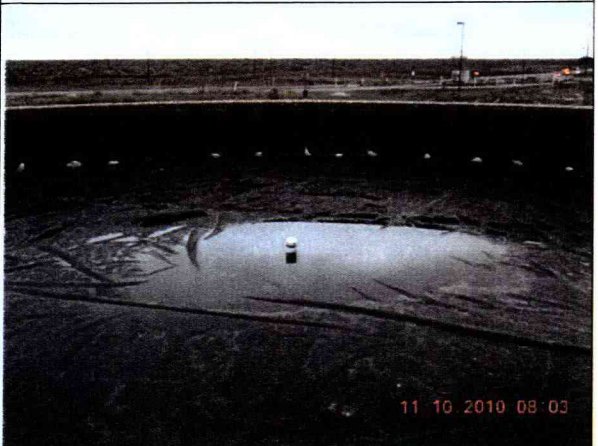
Tank 3- Overnight rains have left standing water in Tank 3.

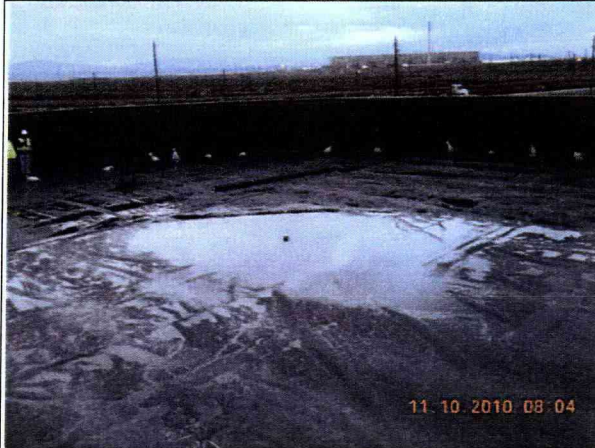
Tank 4- Overnight rains have left standing water in Tank 4.

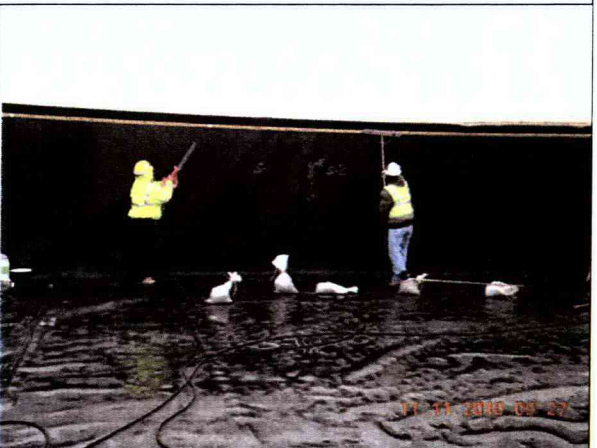
Tank 4-ESI is using an electric leaf blower to dry the liner in Tank 4 so they can continue to weld.

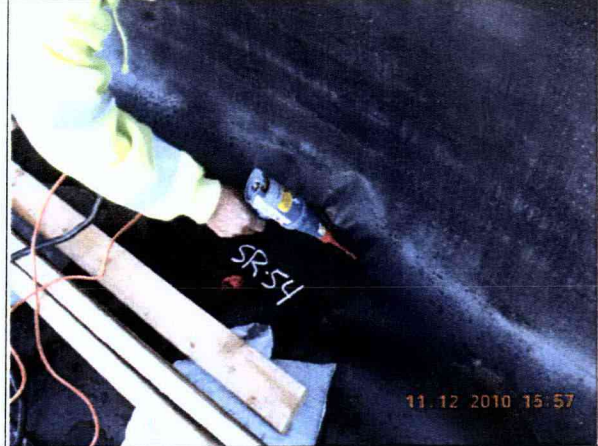
Tank 4-ESI is spark testing the welds in Tank 4 that are inaccessible to the vacuum box.

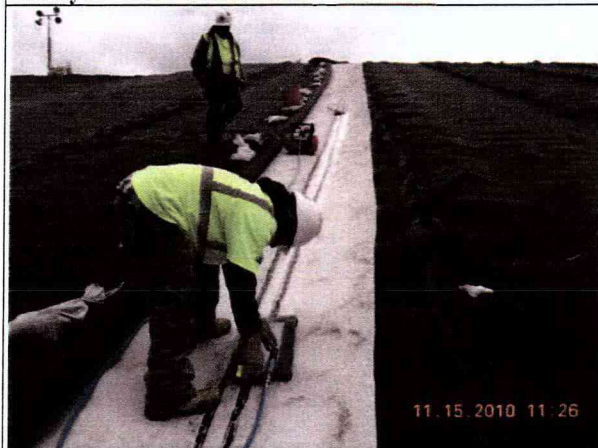
Facing S – ESI is vacuum box testing the extrusion welds on the rain flap on the south slope of Cell 10.

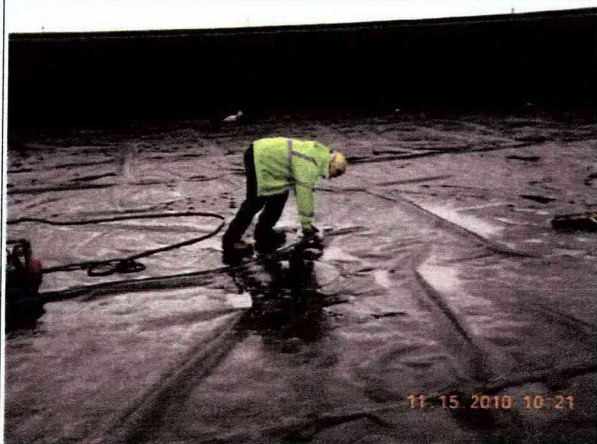
Tank 4 – ESI is finishing the secondary vacuum tests in Tank 4.

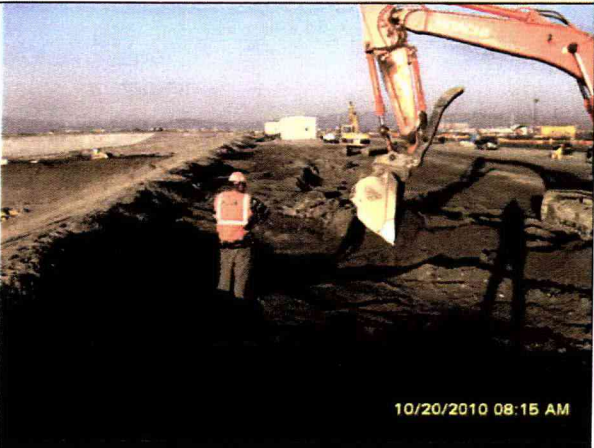
Facing W – TWS excavating the un-welded air release holes left open in liner in the north anchor trench so ESI could complete the welds.

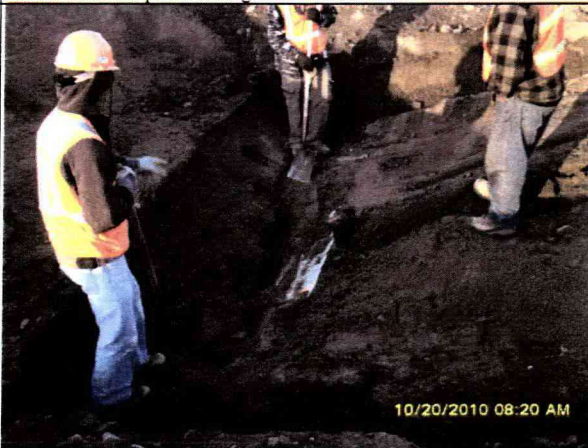
Facing W – TWS excavating the un-welded air release holes left open in liner in the north anchor trench so ESI could complete the welds.

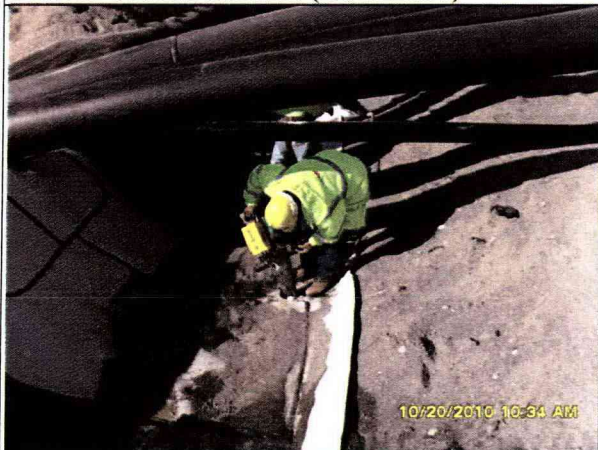
Facing W – ESI also completed welding the anchor trench in the location of the Cell 10 riser pipes.

Facing W – After the welds were completed, TWS backfilled and compacted the excavated holes.

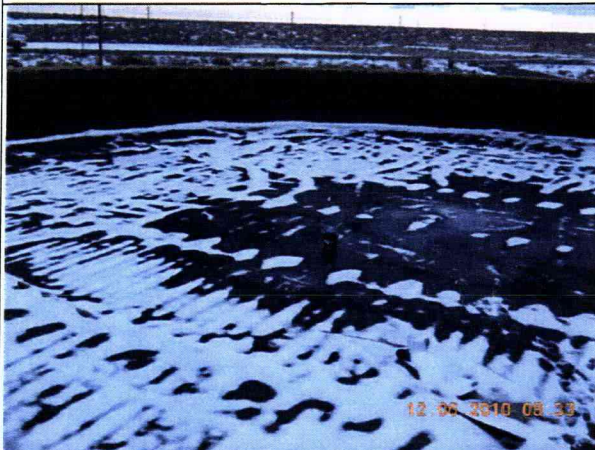
Facing E – Weekend snowstorms blanketed the floor of Tank #3 with snow and ice.

Facing Down – ESI used shovels and heaters to remove snow and ice from the geocomposite on the tank floor.

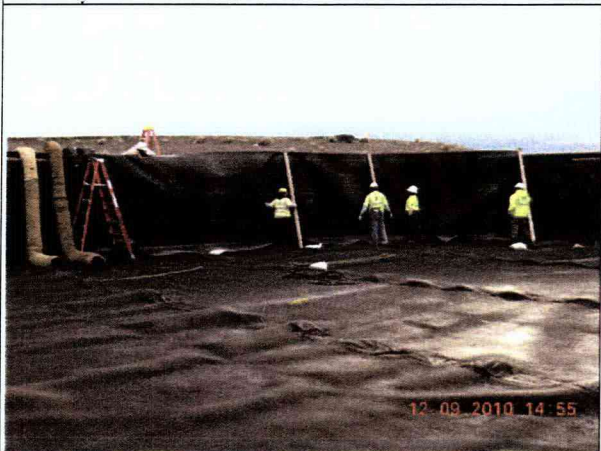
Facing SW – ESI is hanging primary panel P-1 on the south wall of Tank #4.

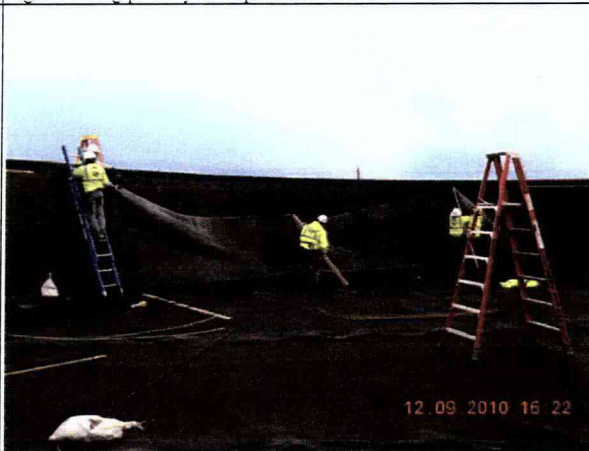
Facing SW – ESI is continuing to hang primary liner panels on the walls of Tank #4.

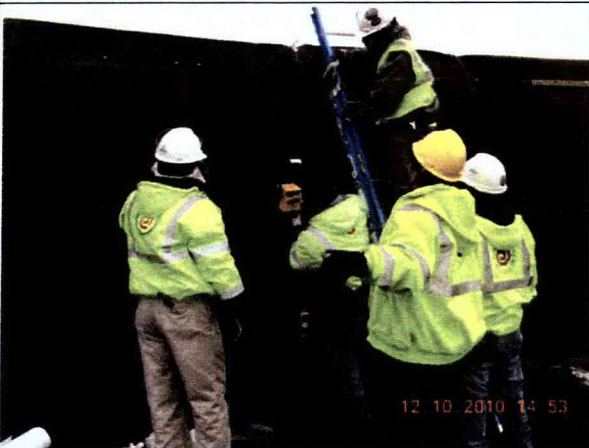
Facing SW – ESI utilizing a double wedge fusion welder to seam the primary panels on the walls of Tank #4.

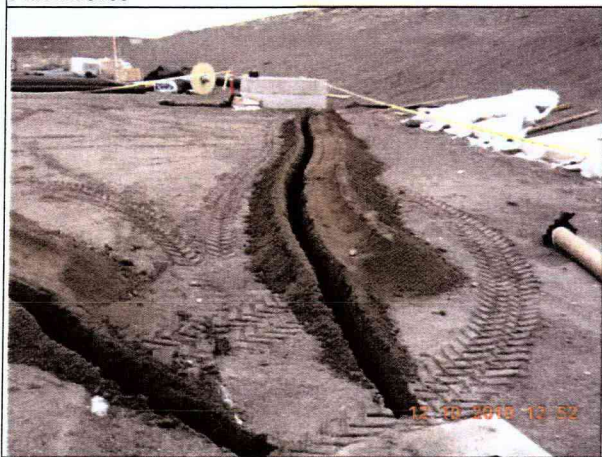
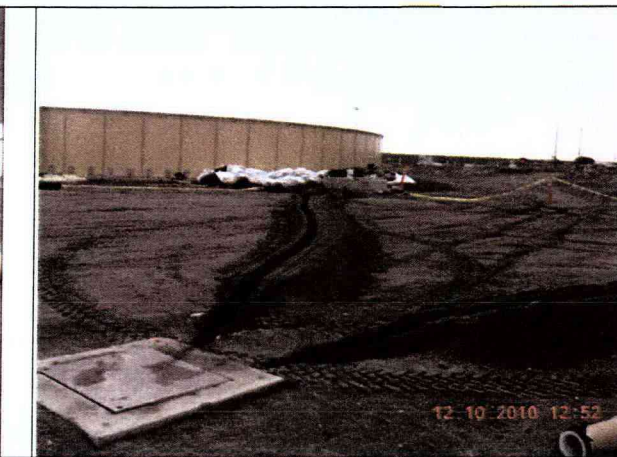
<p>Facing E – American Electric has utilized a Ditch Witch trencher to trench in electrical conduit to MH-38 and MH-39.</p>	<p>Facing NE – American Electric has utilized a Ditch Witch trencher to trench in electrical conduit to MH-38 and MH-39 near Tank #3.</p>

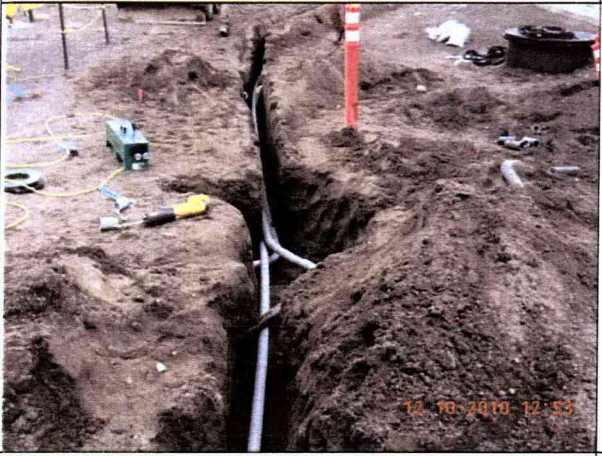
<p>Facing Down – American Electric has utilized a Ditch Witch trencher to trench in electrical conduit to Tan k #3 transducer and MH's #21, #38 and #39.</p>

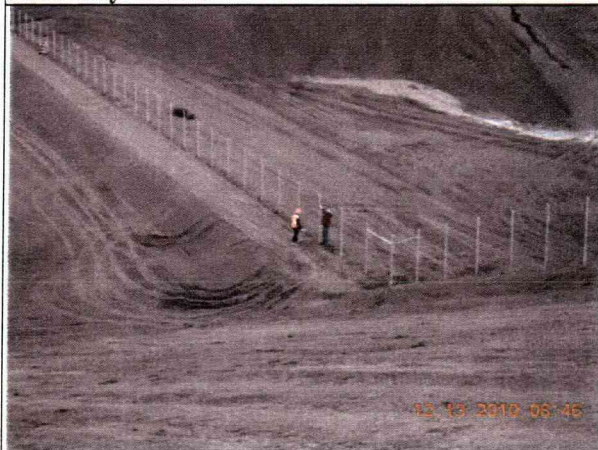
Facing NE – American Fence completing the installation of the Cell 10 termination berm fence.

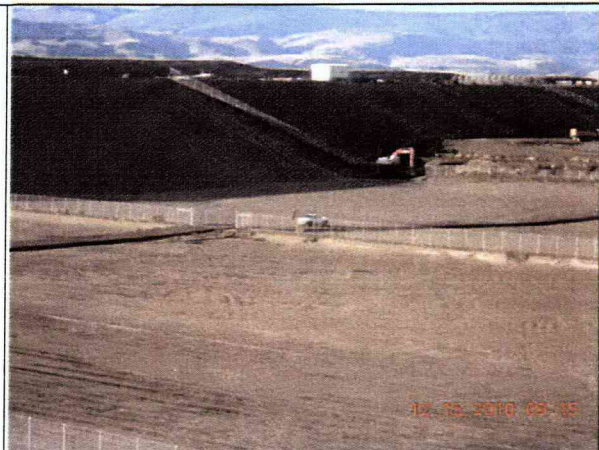
Facing SW – Intermountain Material Testing performing moisture density testing on the operations soil in Cell 9.

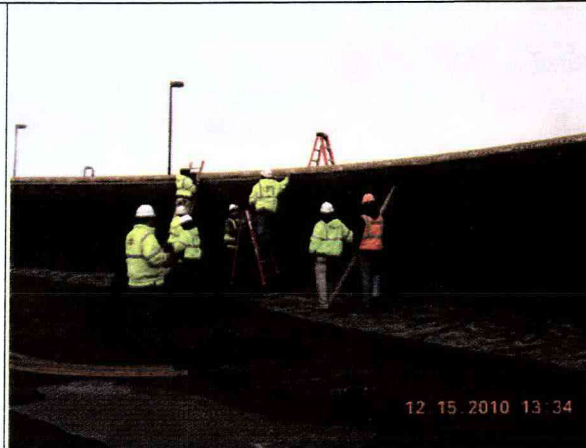
Facing NW – ESI removing the baton strip and anchor bolts in Tank 3 to reposition the secondary geomembrane.

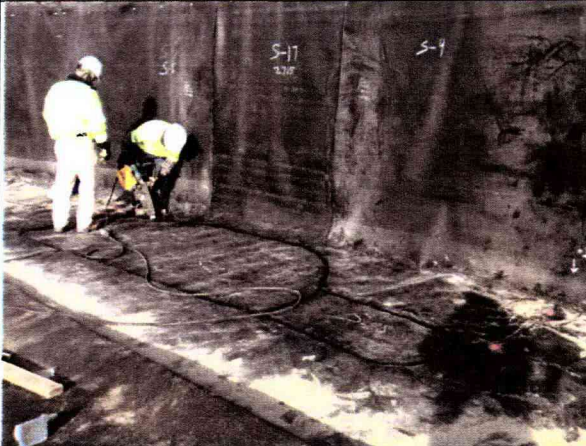
Facing NW – ESI extrusion welding the new panel S-17 in Tank 3 in order to remove the trampoline in the Tank 3 liner.

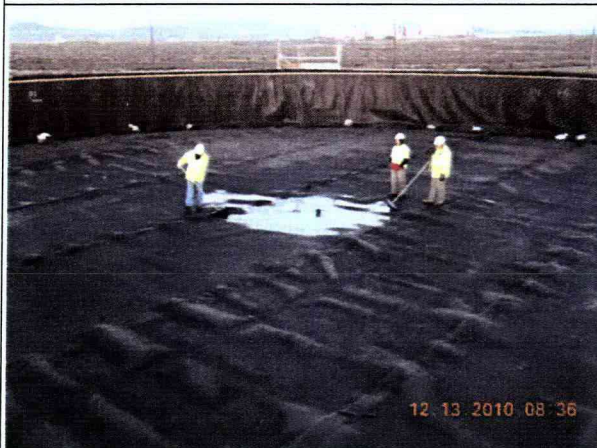
Facing E – ESI removing water and snowmelt from the secondary geomembrane in Tank 4.

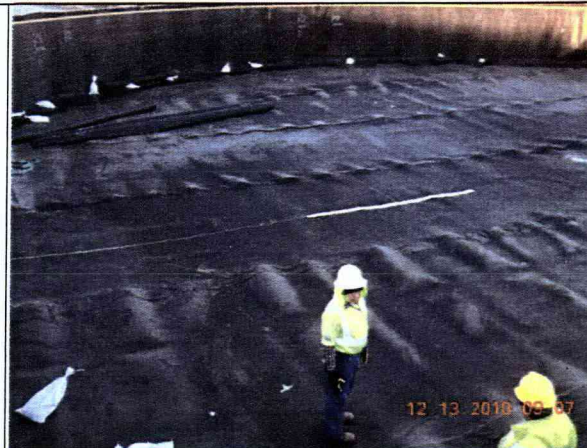
Facing NW – ESI installing the electronic detector to be utilized by LLC during the electronic leak detection survey of the primary liner.

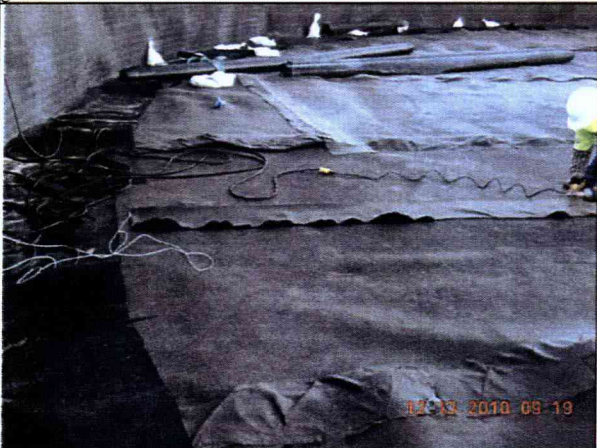
Facing N – ESI heat tacking a piece of geotextile over the electronic detector.

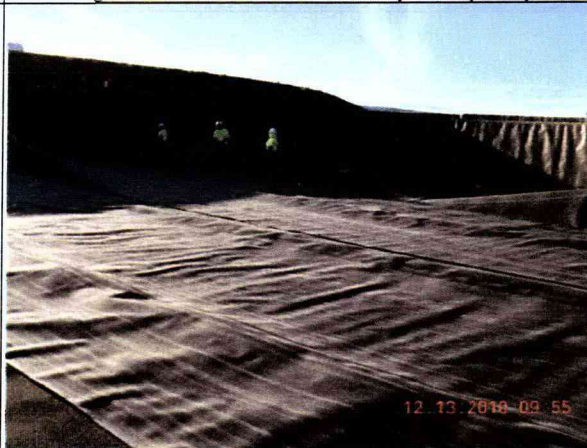
Facing SW – ESI installing the primary geomembrane in Tank 4.

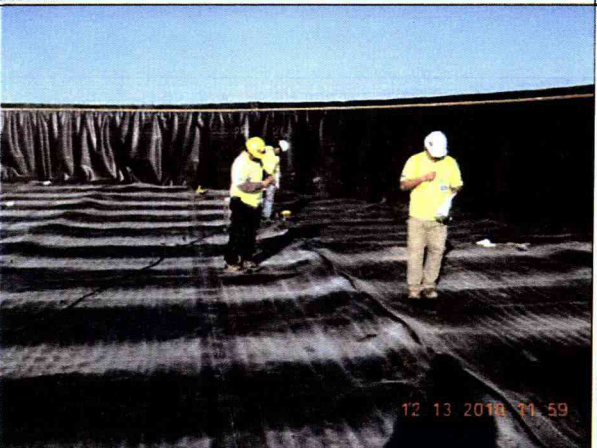
Facing N – ESI welding the primary geomembrane on the floor of Tank 3.

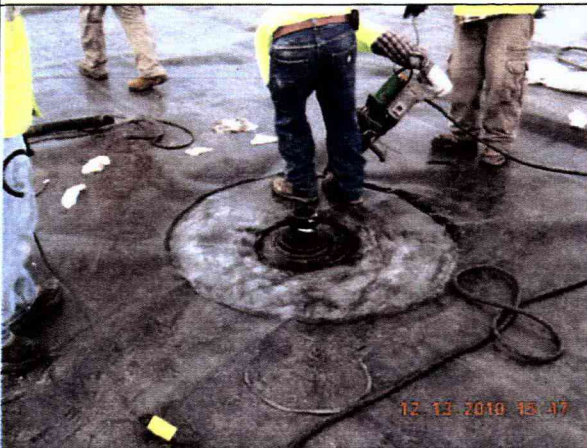
Facing down – ESI welding the floor drain to the primary geomembrane in Tank 4.

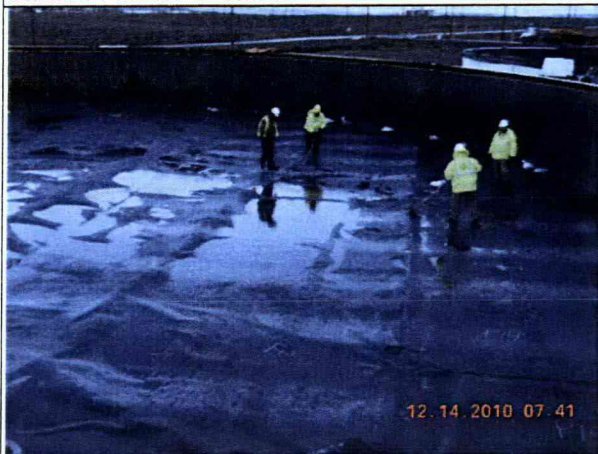
Facing NE - ESI removing storm water from the primary geomembrane in Tank 4.

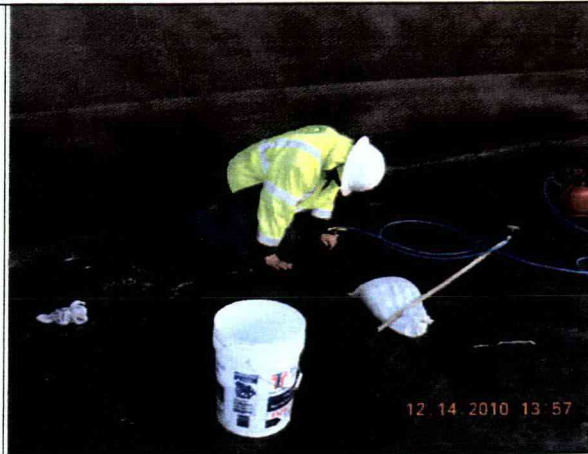
Facing down - ESI performing vacuum testing on the primary geomembrane in Tank 4.

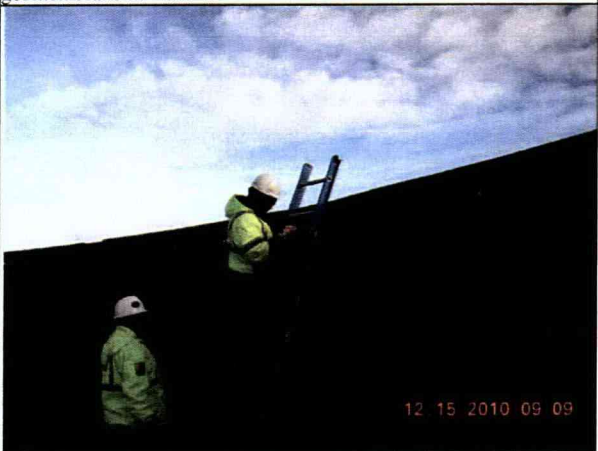
Facing SE - ESI placing the baton strip and anchor bolts in the primary geomembrane in Tank 4.
